**Flood Control Project Maintenance  
Levee Inspections**  
**LMA District Cover Sheet**  
**Spring 2019 Levee Inspection Results**

**Sutter Maintenance Yard Maintenance Area 0017**

Waterway			Bank	Unit Miles
Unit No. 01 Lake County Sutter Maintenance Yard - Middle Creek			Left	3.87
	Spring (March - May)	Summer (June - August)	(September - November) Fall	Winter (December - February)
Unit Maintenance Rating (Fall Only)				
Date of Inspection	4/4/2019 - 4/4/2019			
DWR Inspector	Luz Dial			
Accompanied By

**Levee Inspection Report By Mile - Spring 2019**

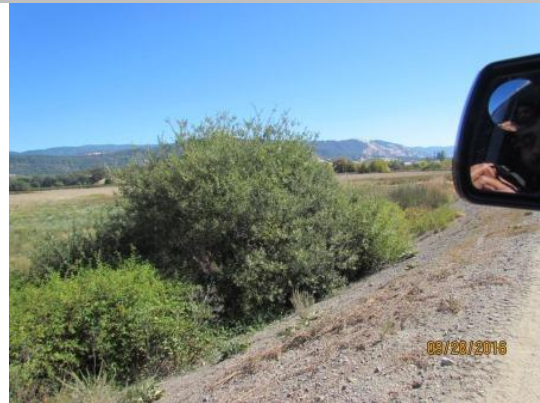
Photo 1 of 1 : SP\_2019\_MA0017\_339\_15\_20190307\_00003.jpg

View of the large bushes limiting visibility and access. Fall 2016

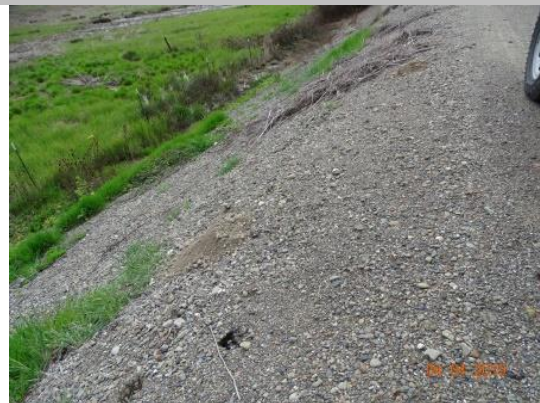
Photo 1 of 2 : SP\_2019\_MA0017\_339\_27\_20190405\_00047.jpg

LM Start	3.47	Rating **	M	Issue No.	27
LM End	3.47	Issue Type +	Ma	Location *	LS
Category	Earthen Levee			GPS Latitude/Longitude	
				Start	End
Item	Animal Control			39.148188 °	39.148188 °
				-122.911572 °	-122.911572 °
DWR ID	DWR_MA0017_01_s _ 2019_27				
Comment Code					
A3 : No rodents visible, but rodent burrows visible; need to backfill and compact or grout burrows.					
Inspector Comment

View looking downstream at animal holes on levee slope. Spring 2019

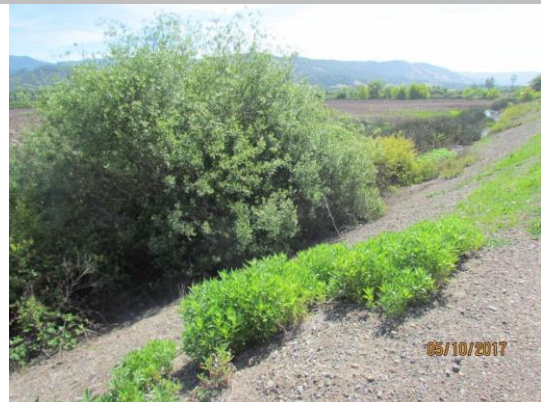
Photo 1 of 1 : SP\_2019\_MA0017\_339\_25\_20190307\_00007.jpg

LM Start	3.84	Rating **	M	Issue No.	25
LM End	3.84	Issue Type +	Ma	Location *	LS
Category	Earthen Levee			GPS Latitude/Longitude	
				Start	End
Item	Trim / Thin Trees			39.144695 °	39.144695 °
				-122.906668 °	-122.906668 °
DWR ID	DWR_MA0017_01_s _ 2017_25				
Comment Code					
T2 : Thin trees to allow visibility of the ground and room to flood fight.					
Inspector Comment					
Trim the trees along the landside toe.

View of the trees along the landside toe. Spring 2017

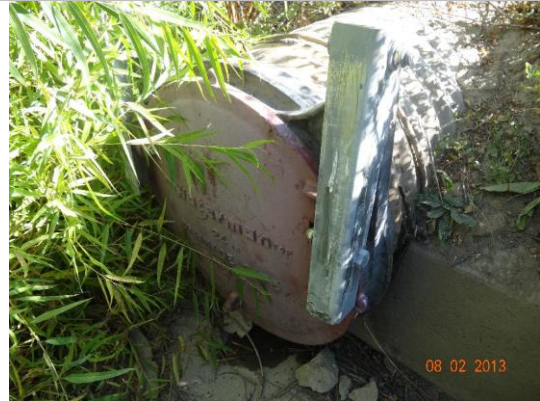
Photo 3 of 3 : UCIP\_SP\_2019\_50814\_46850.jpg

Comment Code						
Inspector Comment						
FS_ID:50814 DS_ID:844 EP_NO: 11463 Repair Type: No Action Needed Crossing Status: Found UCIP Comments: 10/19/2016 Crossing appears to be in good ondition. (DWR Sutter Yard- A Freitag)6/14/2016 crossing appears to be in good condition.4/23/2015 No issues with pipe.7/3/2014 Same as last inspection.12/23/2013 Same as last inspection.8/2/2013 New flap gate installed. No other issues with pipe. FIELD_STRUCT_DESC: 24-inch corrugated metal drainage pipe through the levee, 12.4 feet below the crown. Flap gate on the waterside (WS) end. Timber walkway on the landside (LS) slope to a timber walkway to pump house mounted on piles in drainage ditch. (24- inch pipe [HLM 3.99] authorized under Automatic Board Order (ABO) issued as Permit No. 11463, 1975 - Audrey Jones). [Additional Reference(s): DWR Levee Log, 2005. USACE Sacramento O&M Manual 506.2, August 1961, (HLM 3.99)]. FS Date: 11/21/2016 12:09:38 PM

New flap gate on WS

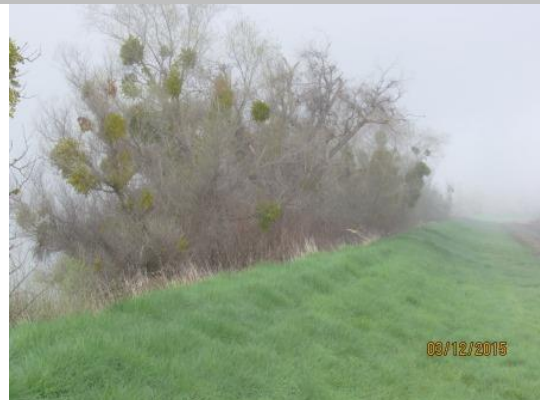
Photo 1 of 2 : SP\_2019\_MA0017\_339\_2\_20190307\_00001.jpg

LM Start	4.16	Rating **	U	Issue No.	2
LM End	7.10	Issue Type +	Ma	Location *	WS
Category	Earthen Levee			GPS Latitude/Longitude	
				Start	End
Item	Trim / Thin Trees			39.141894 °	39.120609 °
				-122.902201 °	-122.887166 °
DWR ID	DWR_MA0017_01_s_2012_2				
Comment Code					
T2 : Thin trees to allow visibility of the ground and room to flood fight.					
Inspector Comment					
Trees and limbs are completely obstructing visibility on crown and WS. Crown is too narrow to drive and overgrown with weeds, brush, and trees. Road follows LS toe.

View of the trees along the waterside slope and toe.

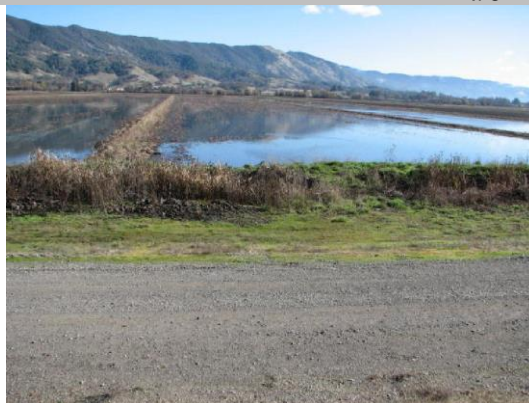
Photo 2 of 2 : UCIP\_SP\_2019\_50817\_46857.jpg

Comment Code						
Inspector Comment						
FS_ID:50817 DS_ID:846 EP_NO: 11462 Repair Type: Non-Urgent Crossing Status: Found UCIP Comments: 10/19/2016 No riser lid or slide gate wheel. (DWR Sutter Yard- A Freitag)6/14/2016 No riser lid and no wheel to operate screw gate. 4/23/2015 Still no lid on riser and wheel to operate slide gate is missing.7/3/2014 Same as last inspection.12/23/2013 Same as last inspection.8/2/2013 Same as last inspection.12/13/2012 No lid on riser-may or may not be an issue. FIELD_STRUCT_DESC: 24-inch corrugated metal drainage pipe through the levee, 19 feet below the crown. Slide gate in 36-inch corrugated metal pipe (CMP) riser on the waterside (WS) slope. (Automatic Board Order (ABO) issued as Permit No. 11462, 1975 - Hobson) [Additional Reference(s): DWR Levee Log, 2005]. FS Date: 11/21/2016 12:11:29 PM

LS toe at approximate location of pipe inlet.

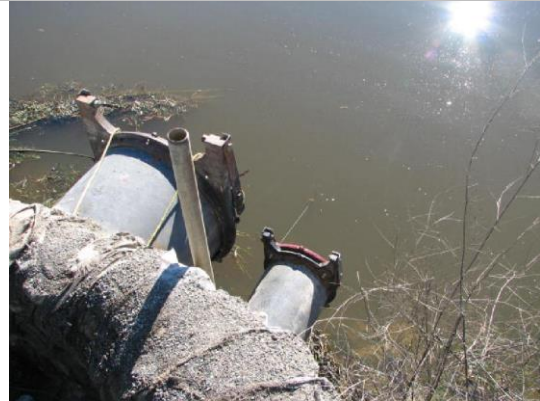
Photo 2 of 2 : UCIP\_SP\_2019\_50818\_46859.jpg

Comment Code						
Inspector Comment						
FS_ID:50818 DS_ID:847 EP_NO: 11469 Repair Type: Non-Urgent Crossing Status: Found UCIP Comments: 10/19/2016 Sack ring still in place. (DWR Sutter Yard- A Freitag)6/14/2016 Sack ring is still built up underneath the pipes.4/23/2015 Sack ring is still built up underneath the pipes.7/3/2014 Same as last inspection.12/23/2013 Same as last inspection.8/2/2013 Same as last inspection.12/13/2012 flood fight materials-ring levees around both LS and WS slopes at pipe crossing. This may or may not be an issue. FIELD_STRUCT_DESC: 1 of 2: 16-inch steel drainage pipe through the levee, 5 feet below the crown. Drainage pumping plant on the landside (LS). Flap gate on the waterside (WS) end. (one 16-inch and one 36-inch pipes [HLM 5.43] authorized under Automatic Board Order (ABO) issued as Permit No. 11469, 1975 - RD 2070). [Additional Reference(s): DWR Levee Log, 2005. USACE Sacramento O&M Manual 506.3, August 1961, (HLM 5.43)]. FS Date: 11/21/2016 12:11:57 PM

16-inch pipe, flap gate, air vent, and ring levee on WS slope.

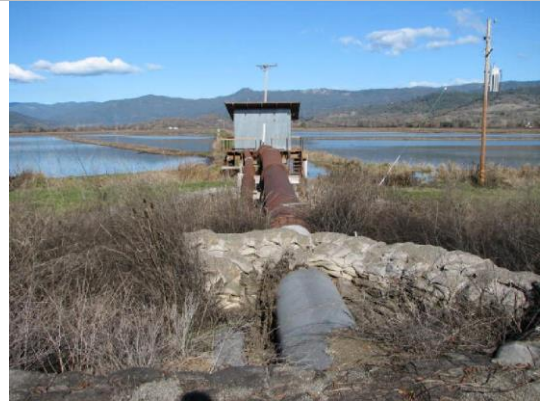
Photo 1 of 2 : UCIP\_SP\_2019\_50819\_46864.jpg

Comment Code						
Inspector Comment						
FS_ID:50819 DS_ID:853 EP_NO: 11469 Repair Type: Non-Urgent Crossing Status: Found UCIP Comments: 10/19/2016 Sack ring still in place. (DWR Sutter Yard- AFreitag)6/14/2016 Sack ring is still built up underneath the pipes.4/23/2015 Sack ring still built up underneath the pipes.7/3/2014 Same as last inspection.12/23/2013 Same as last inspection.8/2/2013 Same as last inspection.12/13/2012 flood fight materials-ring levees around both LS and WS slopes at pipe crossing. This may or may not be an issue. FIELD_STRUCT_DESC: 2 of 2: 36-inch steel drainage pipe through the levee, 5 feet below the crown. Flap gate and air vent on the waterside (WS) slope. (one 36-inch and one 16-inch pipes [HLM 5.43] authorized under Automatic Board Order (ABO) issued as Permit No. 11469, 1975 - RD 2070). [Additional Reference(s): DWR Levee Log, 2005. USACE Sacramento O&M Manual 506.3, August 1961, (HLM 5.43)]. FS Date: 11/21/2016 12:12:31 PM

Pipes and pump house on LS toe with ring levees.

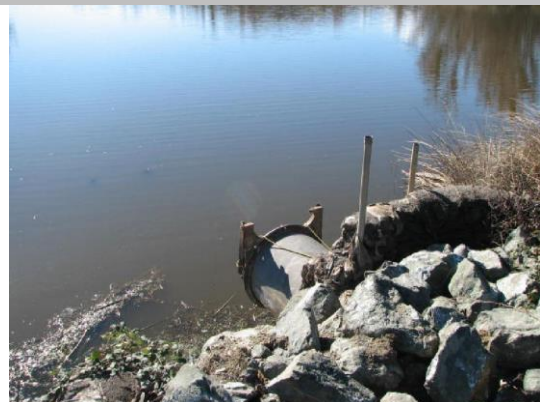
Photo 2 of 2 : UCIP\_SP\_2019\_50819\_46863.jpg

Pipe, flap gate, air vent, and sandbags on WS slope.

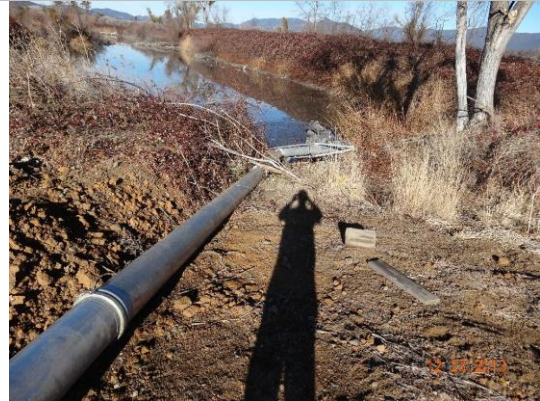
Photo 1 of 1 : UCIP\_SP\_2019\_50823\_47920.jpg

Portable pump on WS and temporary piping over roadway

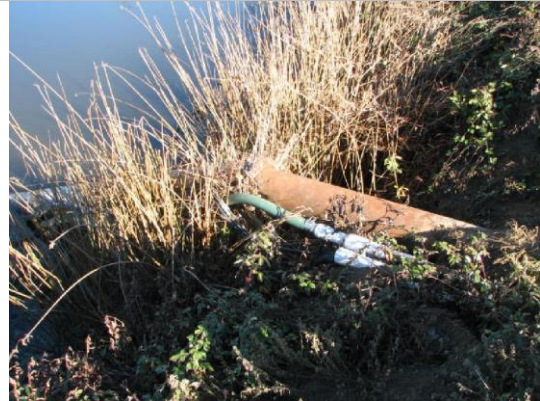
Photo 1 of 3 : UCIP\_SP\_2019\_53325\_46878.jpg

Comment Code						
Inspector Comment						
FS_ID:53325 DS_ID:20587 EP_NO: N/A Repair Type: Urgent Crossing Status: Found UCIP Comments: 9/6/18 Same as last inspection; WS erosion is still present so the crossing remains Urgent (D. Sanoski - DWR UCIP).10/19/2016 WS erosion still present. (DWR Sutter Yard- AFreitag)6/14/2016 WS erosoin is still present. (DWR Sutter Yard - afreitag)4/23/2015 Erosion on WS shoulder is still present. (DWR Sutter Yard - afreitag)7/3/2014 Same as last inspection. (DWR Sutter Yard - afreitag)12/23/2013 Same as last inspection. (DWR Sutter Yard - afreitag)8/2/2013 Erosion on WS shoulder above pipes. (DWR Sutter Yard - afreitag)12/13/2012 No permit for this crossing. This is a primer line, used to fill up main pipe before its pump is turned on (Permit No. 11467). (DWR UCIP - wwylie) FIELD_STRUCT_DESC: 4-inch polyvinyl chloride (PVC) conduit of an unknown purpose through the levee, 2 feet below the crown, with plastic pipe running through it to pump on the landside (LS). No permit has been identified since crossing was field discovered in 2012. FS Date: 9/6/2018 11:26:00 AM

4-inch pvc pipe with green flexible pipe running through it on WS shoulder.

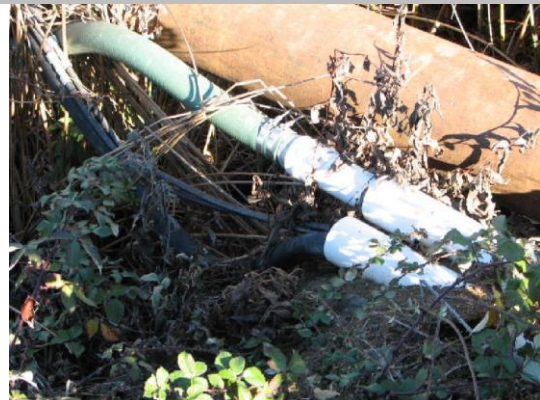
Photo 2 of 3 : UCIP\_SP\_2019\_53325\_46877.jpg

4-inch pvc pipe with green flexible pipe running through it on WS shoulder.

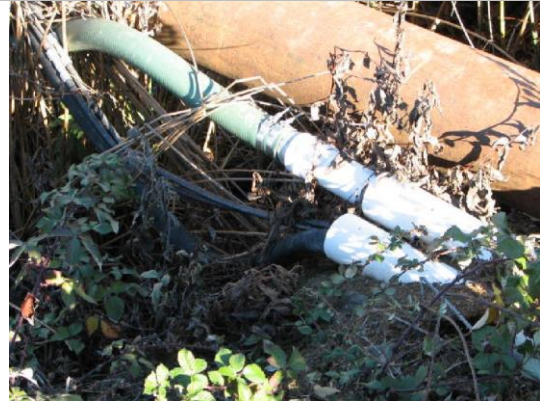
Photo 1 of 3 : UCIP\_SP\_2019\_53324\_46874.jpg

Comment Code						
Inspector Comment						
FS_ID:53324 DS_ID:20588 EP_NO: N/A Repair Type: Urgent Crossing Status: Found UCIP Comments: 9/6/18 Same as last inspection; WS erosion is still present so the crossing remains Urgent (D. Sanoski - DWR UCIP).10/19/2016 WS erosion still present. (DWR Sutter Yard - AFreitag)6/14/2016 WS erosion is still present. (DWR Sutter Yard - afreitag)4/23/2015 Erosion still present on WS shoulder. (DWR Sutter Yard - afreitag)7/3/2014 Same as last inspection. (DWR Sutter Yard - afreitag)12/23/2013 Same as last inspection. (DWR Sutter Yard - afreitag)8/2/2013 Erosion on WS shoulder above pipes. (DWR Sutter Yard - afreitag)12/13/2012 No permit for this crossing. It is unclear what these hydraulic lines are for, but it is probably the works for a hydraulic butterfly valve at the outlet. (DWR UCIP - wwyllie) FIELD_STRUCT_DESC: 4-inch polyvinyl chloride (PVC) conduit of an unknown purpose through the levee, 2 feet below the crown, with hydraulic lines running through it to pump on the landside (LS) shoulder. No permit has been identified since crossing was field discovered in 2012. FS Date: 9/6/2018 11:29:00 AM

Pipe and hydraulic lines on WS shoulder.

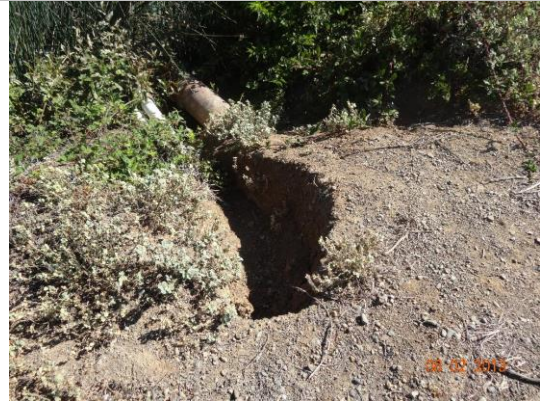
Photo 3 of 3 : UCIP\_SP\_2019\_53324\_46875.jpg

Comment Code						
Inspector Comment						
FS_ID:53324 DS_ID:20588 EP_NO: N/A Repair Type: Urgent Crossing Status: Found UCIP Comments: 9/6/18 Same as last inspection; WS erosion is still present so the crossing remains Urgent (D. Sanoski - DWR UCIP).10/19/2016 WS erosion still present. (DWR Sutter Yard - AFreitag)6/14/2016 WS erosion is still present. (DWR Sutter Yard - afreitag)4/23/2015 Erosion still present on WS shoulder. (DWR Sutter Yard - afreitag)7/3/2014 Same as last inspection. (DWR Sutter Yard - afreitag)12/23/2013 Same as last inspection. (DWR Sutter Yard - afreitag)8/2/2013 Erosion on WS shoulder above pipes. (DWR Sutter Yard - afreitag)12/13/2012 No permit for this crossing. It is unclear what these hydraulic lines are for, but it is probably the works for a hydraulic butterfly valve at the outlet. (DWR UCIP - wwylie) FIELD_STRUCT_DESC: 4-inch polyvinyl chloride (PVC) conduit of an unknown purpose through the levee, 2 feet below the crown, with hydraulic lines running through it to pump on the landside (LS) shoulder. No permit has been identified since crossing was field discovered in 2012. FS Date: 9/6/2018 11:29:00 AM

Erosion on WS shoulder

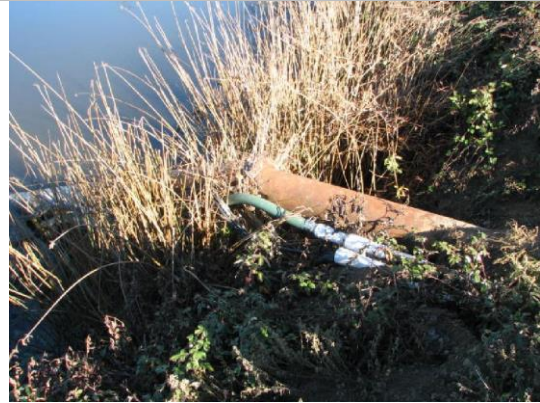
Photo 1 of 3 : UCIP\_SP\_2019\_53323\_46882.jpg

FS\_ID:53323  
DS\_ID:850  
EP\_NO: 11467  
Repair Type: Urgent  
Crossing Status: Found  
UCIP Comments: 9/6/18 Same as last inspection; WS erosion is still present so the crossing remains Urgent (D. Sanoski - DWR UCIP).10/19/2016 WS erosion still present. (DWR Sutter Yard - A Freitag)6/14/2016 WS erosion is still present. (DWR Sutter Yard - A Freitag)4/23/2015 Same as last inspection. (DWR Sutter Yard - A Freitag)7/3/2014 Same as last inspection. (DWR Sutter Yard - A Freitag)12/23/2013 Same as last inspection. (DWR Sutter Yard - A Freitag)8/2/2013 Same as last inspection. (DWR Sutter Yard - A Freitag)12/13/2012 This pipe and appurtenances do not match what was described in the permit (PN: 11467). Does not appear to be in compliance with board regulations. (DWR UCIP - wwylie)  
FIELD\_STRUCT\_DESC: 12-inch steel drainage pipe through the levee, 2 feet below the crown. Butterfly valve on the landside (LS) shoulder. Pump and electrical panel, along with multiple valves and appurtenances, on the LS shoulder. (12-inch pipe [HLM 6.11] authorized under Automatic Board Order (ABO) issued as Permit No. 11467, 1975 - B. F. Modglin[Additional Reference(s): DWR Levee Log, 2005. USACE Sacramento O&M Manual 506.3, 1967, (HLM 6.11)].

12-inch pipe and appurtenances on WS shoulder.

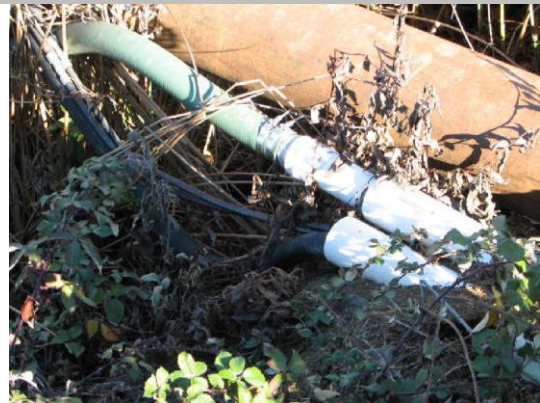
Photo 2 of 3 : UCIP\_SP\_2019\_53323\_46881.jpg

12-inch pipe and appurtenances on WS shoulder.

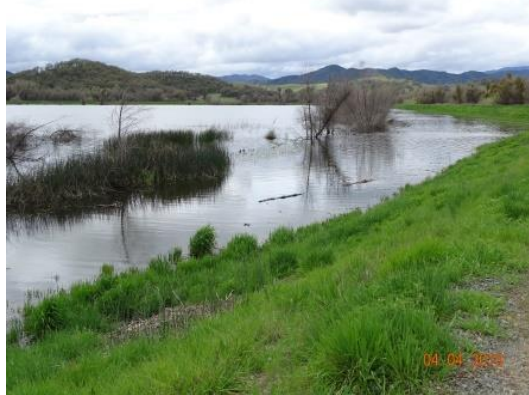
Photo 1 of 2 : SP\_2019\_MA0017\_339\_23\_20190405\_00051.jpg

View of water at the levee toe. Spring 2019

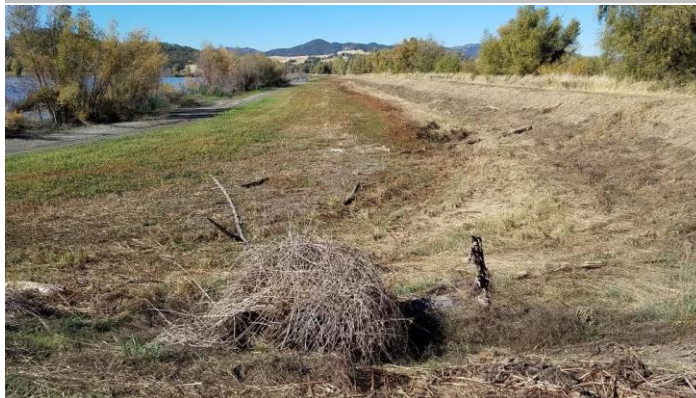
Photo 2 of 2 : SP\_2019\_MA0017\_339\_23\_20190307\_00005.jpg

LM Start	<b>6.08</b>	Rating **	U	Issue No.	<b>23 (cont)</b>
LM End	<b>7.28</b>	Issue Type +	Ob	Location *	LS

View of the water away from the levee slope. Fall 2018

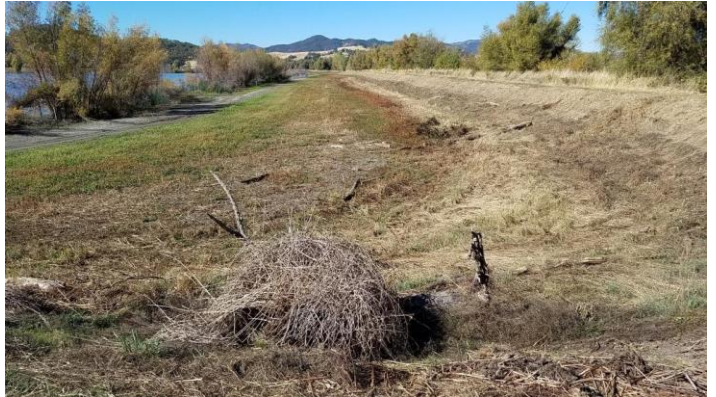
Photo 1 of 1 : SP\_2019\_MA0017\_339\_28\_20190307\_00008.jpg

View of debris on the landside toe. Fall 2018

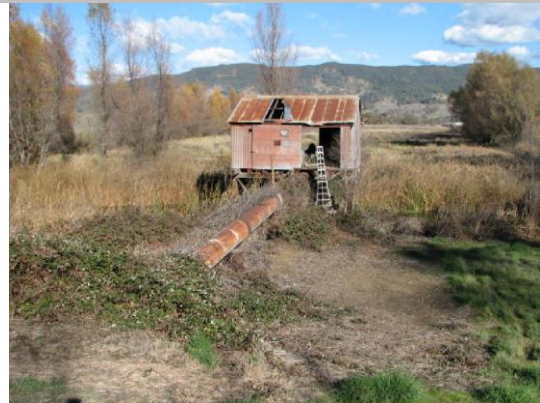
Photo 1 of 2 : UCIP\_SP\_2019\_50827\_46884.jpg

Comment Code					
Inspector Comment					
FS_ID:50827 DS_ID:851 EP_NO: 11467 Repair Type: Non-Urgent Crossing Status: Found UCIP Comments: 10/19/2016 Abandoned- should be done so properly. (DWR Sutter Yard- AFreitag)6/14/2016 Abandoned crossing.4/23/2015 Same as last inspection. Pipe still needs to be properly abandoned.7/3/2014 Same as last inspection.12/23/2013 Same as last inspection.8/2/2013 Same as last inspection.12/13/2012 Pipe should be properly abandoned. FIELD_STRUCT_DESC: *ABANDONED* 1 of 2: 16-inch steel drainage pipe through the levee, 8 feet below the crown. Drainage pumping plant on the landside (LS). Flap gate on the waterside (WS) end. Steel plate welded on end of pipe at LS toe. (one 16-inch and one 24-inch pipes [HLM 7.79] authorized under Automatic Board Order (ABO) issued as Permit No. 11467, 1975 - Modglin[Additional Reference(s): DWR Levee Log, 2005. USACE Sacramento O&M Manual 506.3, August 1961, (HLM 7.19)]]. FS Date: 11/21/2016 12:16:52 PM

Pumping plant in shed on LS at drainage ditch.

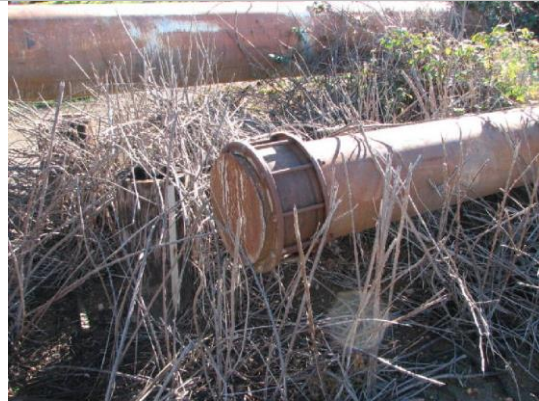
Photo 2 of 2 : UCIP\_SP\_2019\_50827\_46883.jpg

Comment Code						
Inspector Comment						
FS_ID:50827 DS_ID:851 EP_NO: 11467 Repair Type: Non-Urgent Crossing Status: Found UCIP Comments: 10/19/2016 Abandoned- should be done so properly. (DWR Sutter Yard- A Freitag)6/14/2016 Abandoned crossing.4/23/2015 Same as last inspection. Pipe still needs to be properly abandoned.7/3/2014 Same as last inspection.12/23/2013 Same as last inspection.8/2/2013 Same as last inspection.12/13/2012 Pipe should be properly abandoned. FIELD_STRUCT_DESC: *ABANDONED* 1 of 2: 16-inch steel drainage pipe through the levee, 8 feet below the crown. Drainage pumping plant on the landside (LS). Flap gate on the waterside (WS) end. Steel plate welded on end of pipe at LS toe. (one 16-inch and one 24-inch pipes [HLM 7.79] authorized under Automatic Board Order (ABO) issued as Permit No. 11467, 1975 - Modglin[Additional Reference(s): DWR Levee Log, 2005. USACE Sacramento O&M Manual 506.3, August 1961, (HLM 7.19)]. FS Date: 11/21/2016 12:16:52 PM

Steel plate welded over end of pipe at LS toe.
